National Energy
Board

**Subject: National Energy Board Safety Advisory
NEB SA 2004-02**

Failures of Threaded Connections

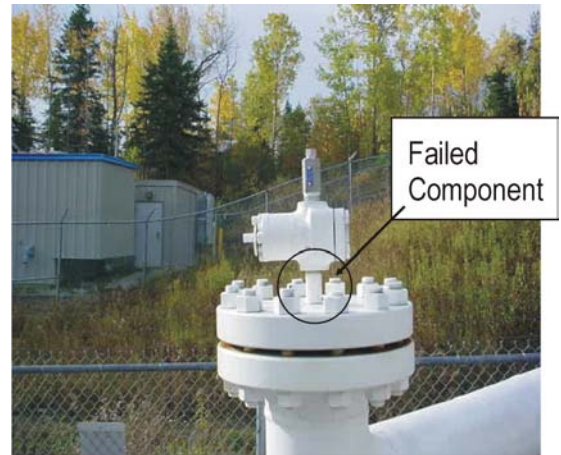
On 15 October 2004 a 33.4 mm (NPS 1) x 100 mm (4-inch) threaded both ends nipple failed at the interface between the threads of the nipple and a flange in high pressure sweet natural gas service. The failure was noted as the piping assembly was being pressurized. An undetermined small amount of sweet natural gas was released to the atmosphere. A photograph of the failed piping assembly is provided.

The failures typically occur as a result of stresses imposed through normal operation compounded by the stress concentrating effect of the threaded connection. The nipple acted as a lever arm in applying a moment at the connection to the flange. Operation of a plug valve mounted on the nipple and vibration of the piping contributed to the failure.

Piping should be designed to avoid unnecessary stress concentrators where practicable. Extreme caution should be taken in the design of threaded connections where movement or externally applied forces can apply excessive stress to threaded joints. Where these stresses are unavoidable, the use of welded connections is preferable. In addition, piping supports should be considered as a means to reduce the moments applied to the joint by external forces.

Existing piping configurations should be assessed and, where necessary, modifications should be made to reduce the possibility of failure.
